# Manhole Inspection Summary

Manhole # S13QQ\_011MH

Insp Date: **9/17/07 3:11 PM**

**Location** Address: **LEMMEL MIDDLE SCHOOL**

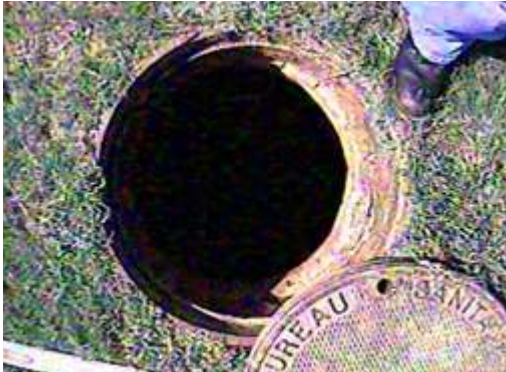
Defect 1

Offset: **2** (in.)

OFFSET FRAME

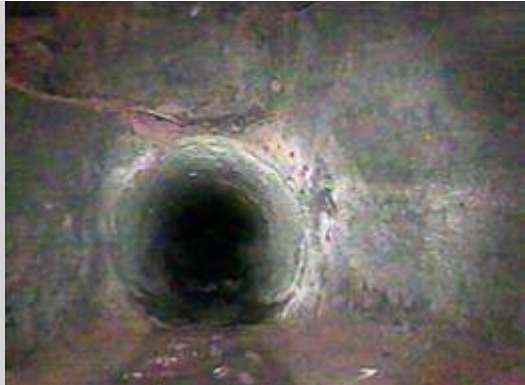
12 O'Clock Outflow

10 in. Circular Gravity Sewer  
Pipe Out @ 12 O'Clock

Pipe Height: **6** (in.) Rod and Bar  
Pipe Material: **PVC** ☐ Pipe Lined  
Invert Depth: **15.20** (ft.) Flow Characteristics: **Fast**  
Deposits: ☒ None ☐ Mud ☐ Sludge ☐ Debris ☐ Grease  
Silt Depth: (in.) Deposits Extent:  
Infiltration: **None** Pipe Seal Cond: **Sound**

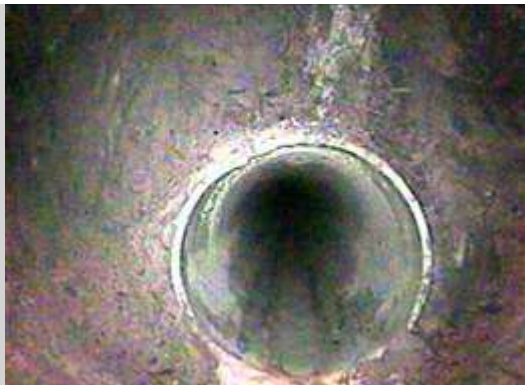
4 O'Clock Inflow

10 in. Circular Gravity Sewer  
Pipe In @ 4 O'Clock

Pipe Height: **6** (in.) Rod and Bar  
Pipe Material: **PVC** ☐ Pipe Lined  
Invert Depth: **15.13** (ft.) Flow Characteristics: **Fast**  
Deposits: ☒ None ☐ Mud ☐ Sludge ☐ Debris ☐ Grease  
Silt Depth: (in.) Deposits Extent:  
Infiltration: **None** Pipe Seal Cond: **Sound**

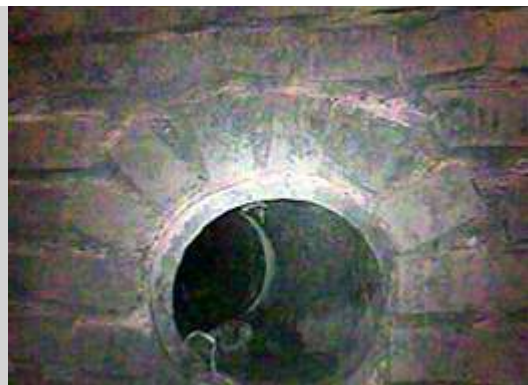
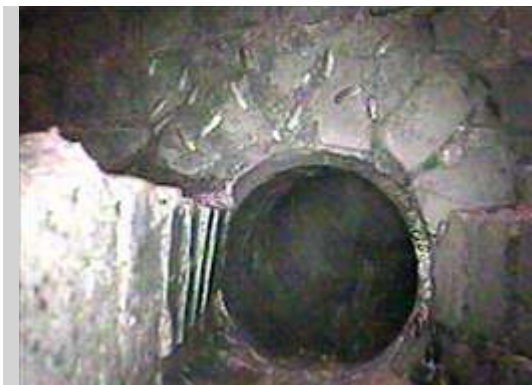
6 O'Clock Inflow

Pipe In @ 6 O'Clock

Drop In @ 6 O'Clock

Infiltration: **None** Pipe Seal Cond: **Sound**

Drop: **Outside** **Direct**

Drop Condition: **Open**
